KENT COUNTY COUNCIL

EAST KENT EMPTY PROPERTIES INITIATIVE

SHEPWAY REPORT

June 2005

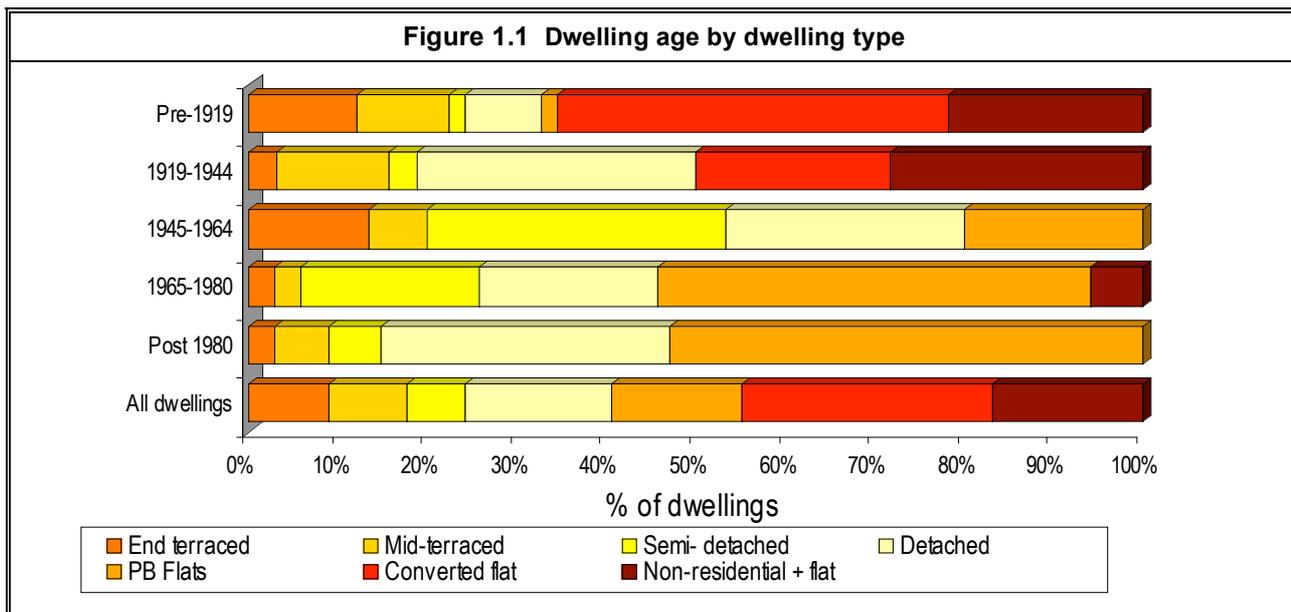
The following tables correlate some of the dwelling type and age. The most significant trends include the high proportion of non residential buildings with flats and converted flats in pre-1919 built dwellings. Furthermore, purpose-built flats are much more likely to be found in dwellings built after 1965.

Age of dwelling	Type of dwelling							Total
	End terraced	Mid-terraced	Semi-detached	Detached	PB Flats	Converted flat	Non-residential + flat	
Pre-1919	20	17	3	14	3	72	36	165
1919-1944	1	4	1	10	0	7	9	32
1945-1964	2	1	5	4	3	0	0	15
1965-1980	1	1	7	7	17	0	2	35
Post 1980	1	2	2	11	18	0	0	34
Total	25	25	18	46	41	79	47	281
